ISLEWORTH AND SYON SCHOOL FOR BOYS

CONDITION SURVEY SUMMARY REPORT

SPINT LIMITED

OCTOBER 2012

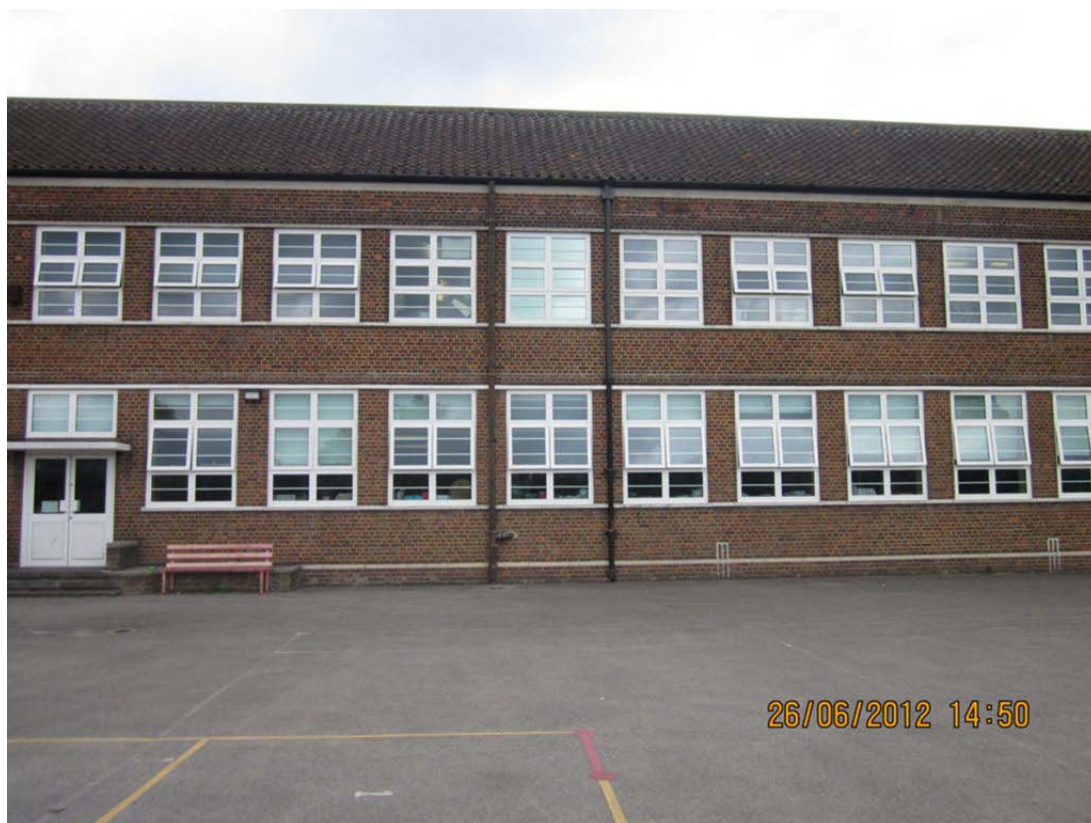
Figure 1- Exterior of Block A

The majority of the building has a precast reinforced concrete frame with elevations of brickwork and a mixture of aluminium, steel and timber framed windows. The Sports Hall however is a steel framed building.

Large areas of the flat roof coverings are very worn and will need to be replaced within the next 2-3 years. Some areas have had their coverings replaced recently but water pooling shows that the roof structure in some of these areas is defective.

The rainwater goods are in poor condition. The gutters were noted to be blocked, open jointed and leaking a numerous places around the block. It is recommended that the gutters and downpipes are clean out, repaired and left fully operational. The detailing of the gutters is very poor and will make cleaning out of the gutters difficult. All cast iron rainwater goods will need to be replaced.

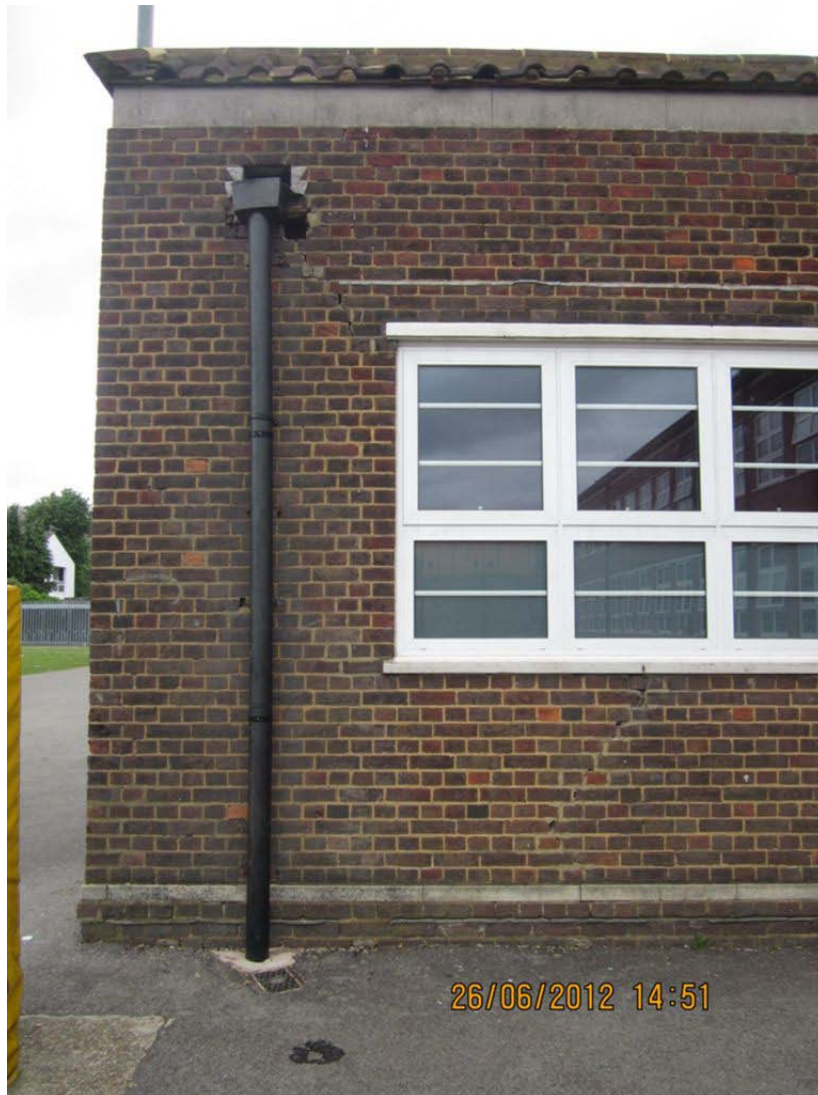
Figure 2- Stepped Cracking Outside Sixth Form Common Room

Stepped cracking was noted above and below a window outside the Sixth Form Common Room. The cracking is indicative of ground movement. There is a downpipe and gully located close to this area of cracking. The external walls to this corner will need to be rebuilt and it is anticipated works to the drainage will also be required.

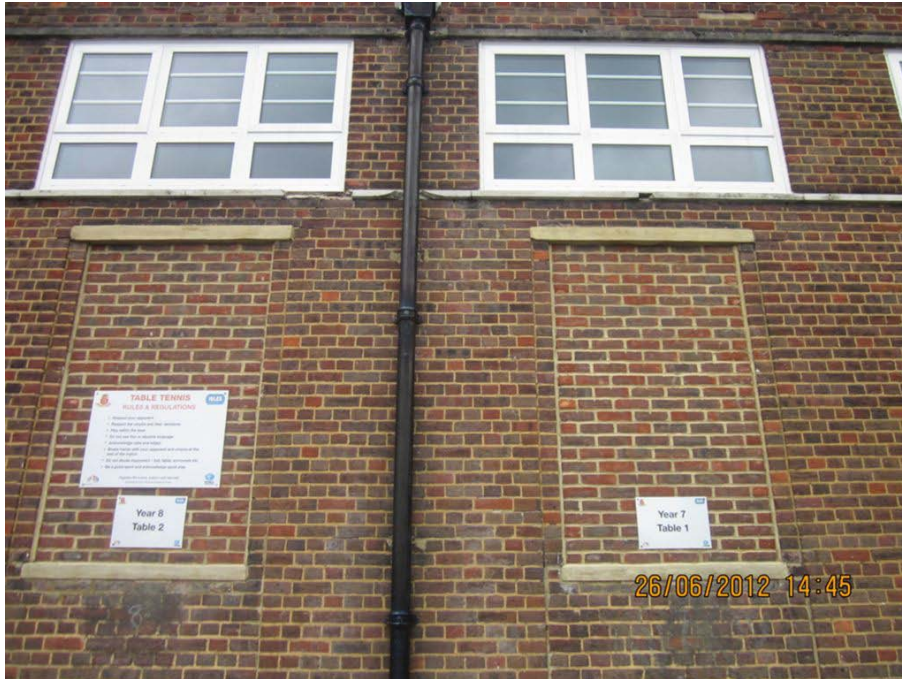
Figure 3- Defective Concrete Structural Elements

Deterioration to the concrete structural elements was noted in a number of locations. Extensive epoxy resin concrete repairs should be carried out to the ring beams and continuous concrete cills.

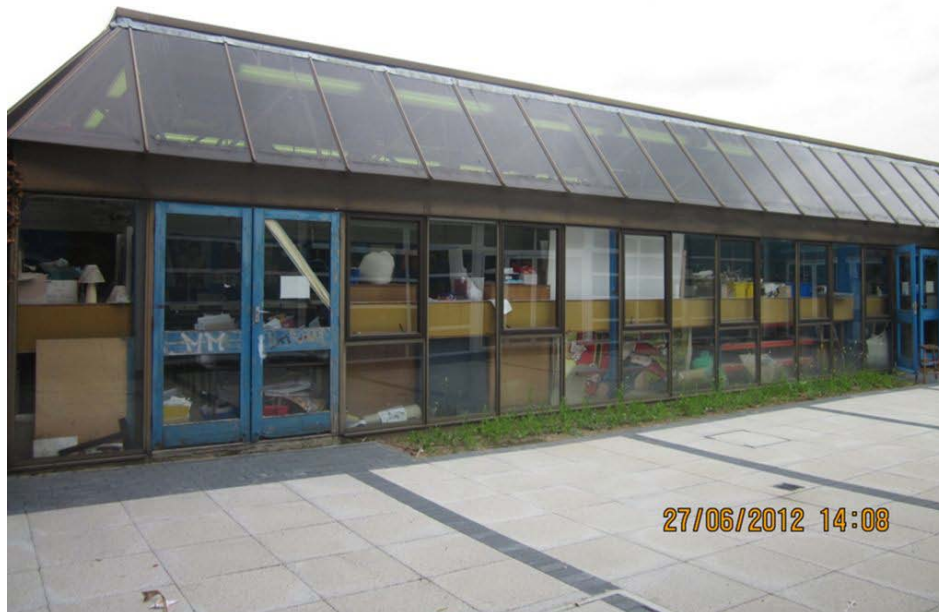
A number of timber external doors were noted to be rotten and require replacement.

Figure 4- External Timber Doors in Poor Condition

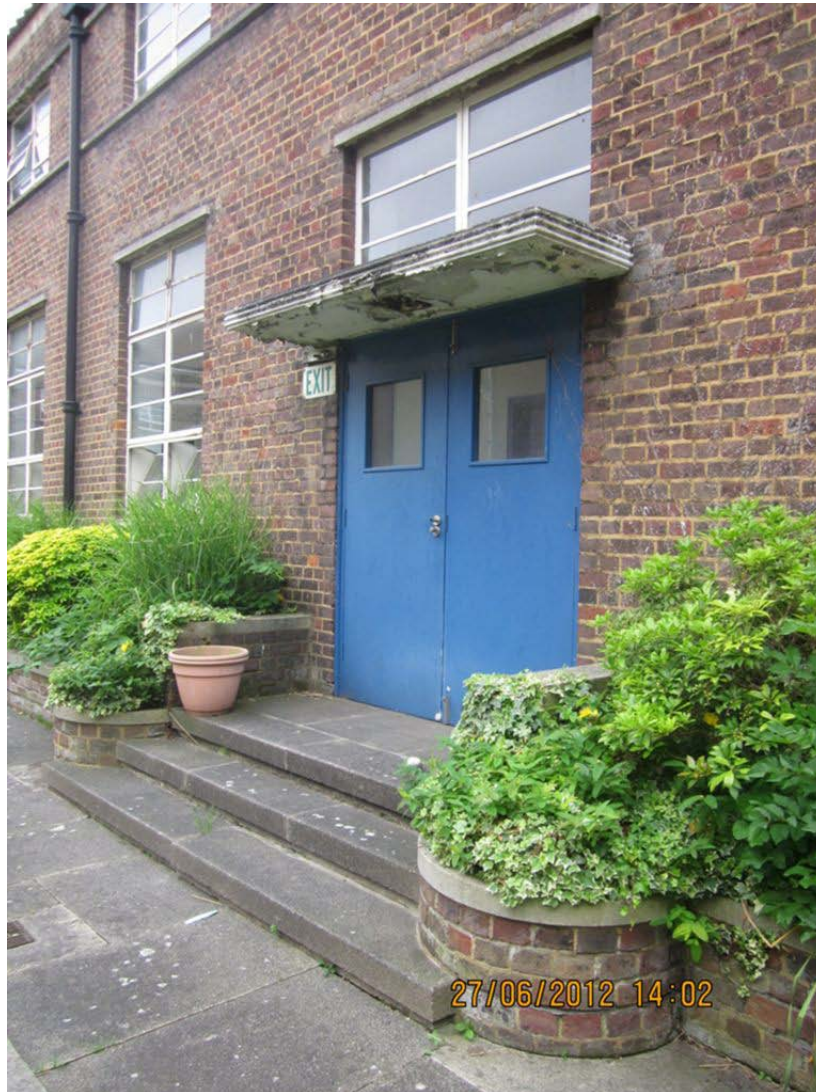
There were a number of concrete canopies, above external doors, around the block which require attention.

Figure 5- Defective Concrete Canopies

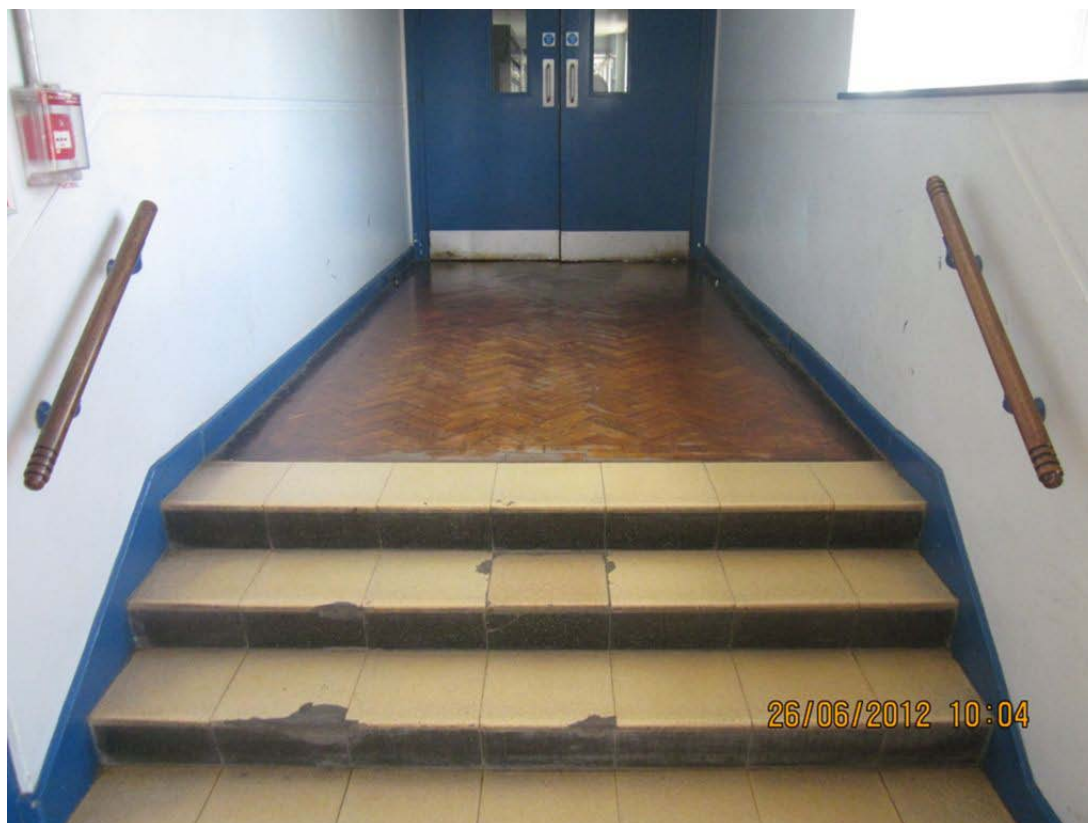
Figure 6- Poor Condition of Floor Coverings to Stairs

A number of staircases around the block were noted as having ceramic floor tiles or vinyl coverings which were damaged and worn, causing potential trip hazards. It is recommended that the coverings of all staircases are replaced with a suitable alternative material.

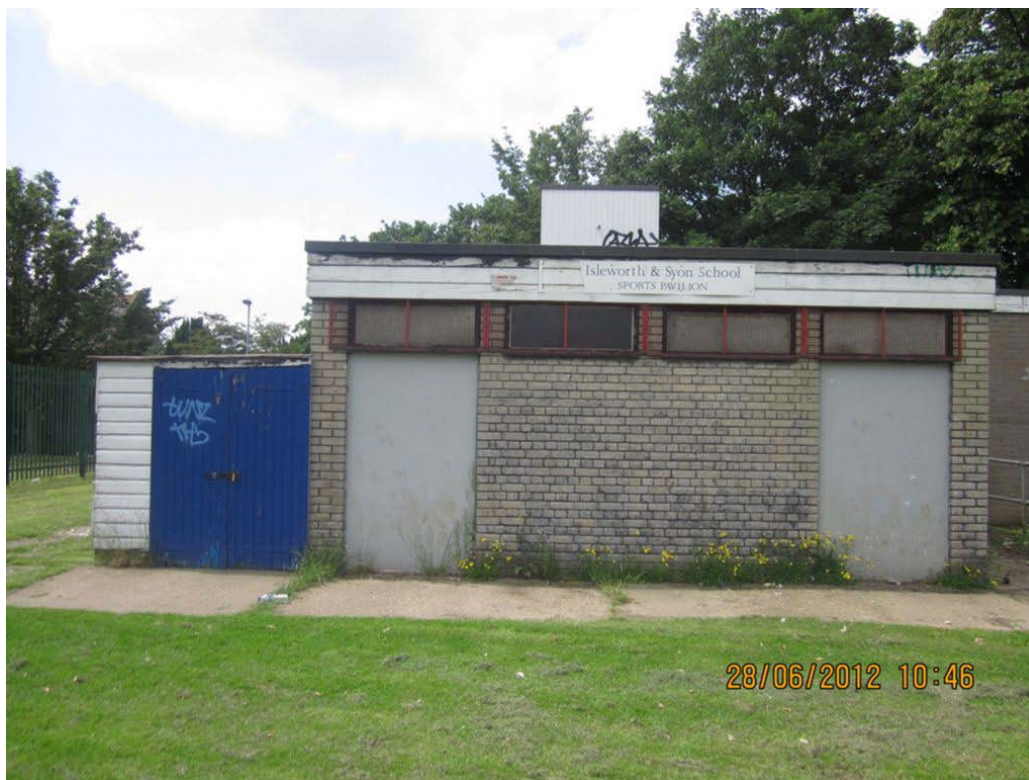
Figure 7- Exterior of Block C

The fabric of this building is generally in poor condition and full internal and external refurbishment works will be required over the next 5 year maintenance period.

The timber cladding and fascia boards were noted to be rotten in places and required complete replacement.

The gutters and downpipes were missing with only some sections of guttering which was in poor condition remaining. New rainwater goods are required around the block.

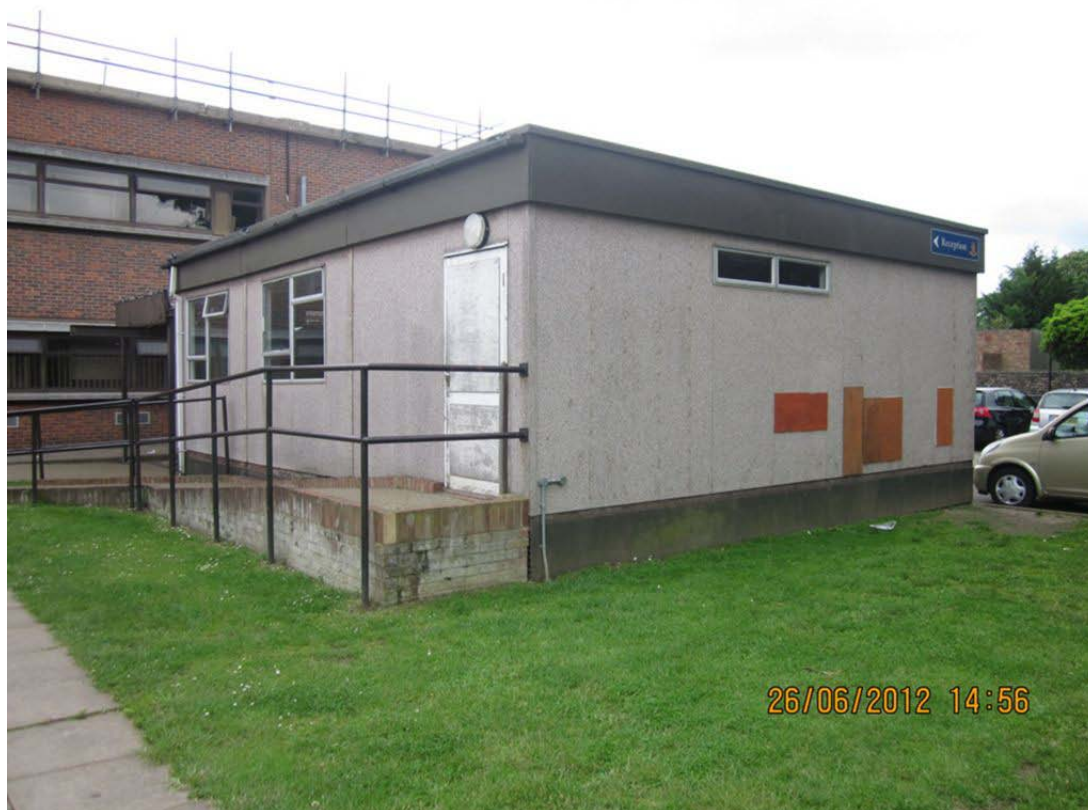
Figure 8- Exterior of Block Td

The external walls to block Td were noted to have been patched up with timber boarding. This suggests that the wall structure has failed and will need to be replaced. The block also requires the replacement of its rainwater goods and a timber shelter adjacent to this block requires refurbishment works.

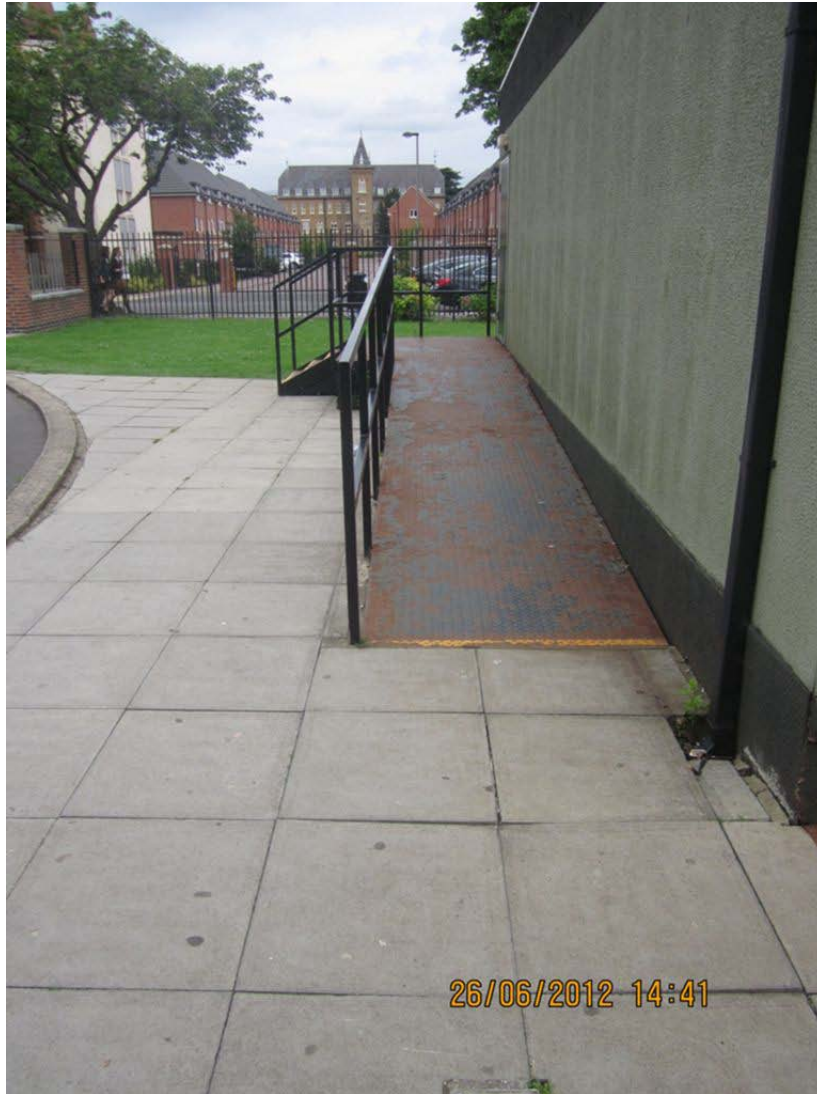
The metal access ramps to block Te were noted to be severely corroded and will need to be replaced.

Figure 9- Corrosion to Access Ramps
